# 'The Fatal 6' - Unsafe Work at Height & Isolation Breach

**ALERT STATUS:** High Potential  
DATE ISSUED: 03/04/2020 16:35:57  
INCIDENT No: 02554

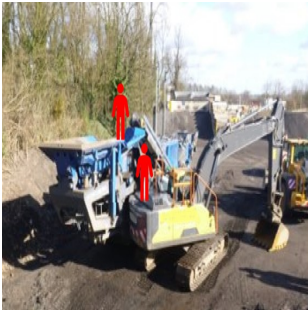
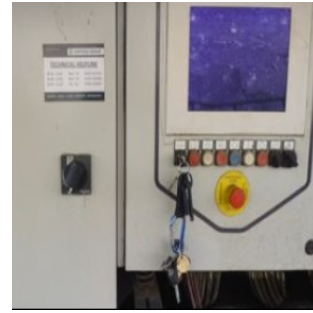
Contractors were observed working unsafely on a mobile crusher - the crusher wasn't fully isolated as per Company procedures and their transport vehicle was left unattended with the engine running.

- Unauthorised maintenance was being carried out by the contractor

- Equipment was not fully isolated by the contractor and the contractor did not contact any Company employee regarding the need for isolation

- Work at height was not controlled adequately or an authorised activity by the contractor

- All contractors must have a specified Company person who will be their point of contact
- The Company person must carry out and document regular interactions with the contractors whilst on site to ensure task-specific controls are in place and being followed
- All equipment before being worked on must have a Company isolation owner
- All working at height must be adequately controlled through robust HIRA (Hazard Identification & Risk Assessment) and Methods of Work
- All work carried out by contractors must be authorised by Company management.
