INCIDENT ALERT

LOCATION:	AGGREGATE DREDGER	ALERT STATUS:	Normal
ACTIVITY:	MARINE OPERATIONS	DATE ISSUED:	17/06/2020 16:49:12
SUB ACTIVITY:	DREDGING	INCIDENT No:	02564

Finger dislocation on induction tour - BMAPA alert

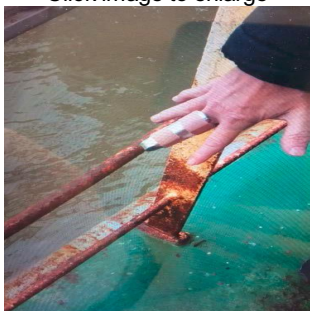
During this walk around the IP lost his footing on a rogue stone on the safety walkway put out his hand to steady himself and caught his finger on the middle safety railing causing it to bend back and dislocate.

Vessels to conduct a Safety Briefing discussing the above incident highlighting the importance of conducting a good briefing with new unfamiliar crew members before conducting a tour of the vessel, reminding of the importance of being vigilant when conducting routine activities.
