Fall from Tipper

CEMENT PLANT
TRANSPORT & LOGISTICS / DELIVERY
PRODUCT DELIVERY

ALERT STATUS: Normal
DATE ISSUED: 25/06/2011
INCIDENT No: 00290

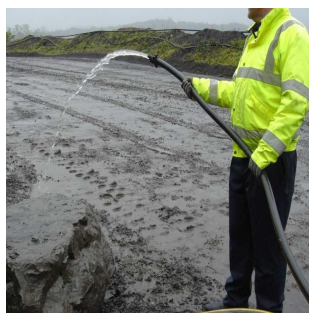
Picture 1: Pump Inoperative

On inspection, the water pressure at the wash station was not sufficient to allow the 'jet' of water to reach the full length of a tipper (picture No:1) and this may have been the reason why the wash station was not used. Further investigation found that the wash station boost pump had tripped, once reset the station operated as intended (picture No:2).

The supervision and control of contractors is paramount and where local rules are in place they must be enforced and policed at all times. All equipment must be suitable & sufficient for the task that it is intended.
