INCIDENT ALERT

ALERT STATUS: Normal
DATE ISSUED: 05/07/2011
INCIDENT No: 00291

Chassis Failure Komatsu 350 Dumper

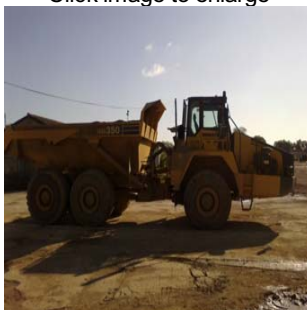
An inspection of the dumper was undertaken and it was discovered that the near-side tractor unit chassis had a large split running through it. This made the vehicle un-safe and it was immediately taken out of service.

Plant

- Pressure wash and conduct a thorough chassis inspection of all Komatsu HM 350 and HM400 dumpers.
- A known indicator of this problem is a widening of the gap where the battery box abuts the wheel arch.
- Where there is any doubt contact John Taylor, Product Support Manager at Marubeni Komatsu, who will arrange for a service engineer to visit. (Editors note: Other company's may need to make their own arrangements for a specialist inspection).

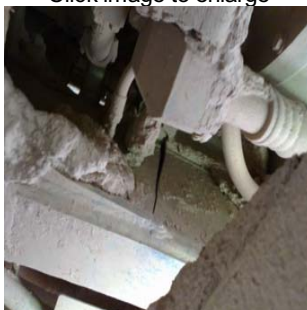
Split Chassis
