INCIDENT ALERT

LOCATION: CEMENT PLANT
ACTIVITY: PRODUCTION AND PROCESSING
SUB ACTIVITY: CEMENT PRODUCTION

ALERT STATUS: Normal
DATE ISSUED: 04/12/2012
INCIDENT No: 00347

Cardox Shell Incident

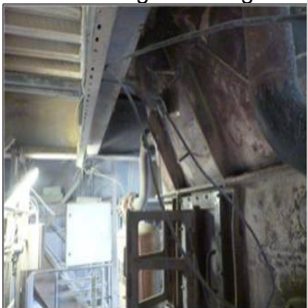
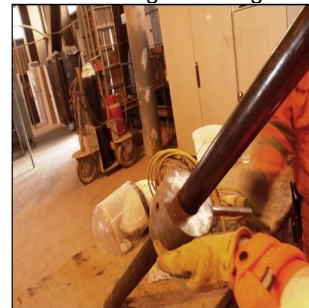
During routine cardox use, a shell was ejected from the retaining collar striking a hand rail and resulting in minor damage to a water pipe.

Two sizes of retaining collar were available for use, the larger internal sized collar was being used with the smaller diameter shell.

A manufacturing defect had resulted in ridges at the welded seam of the shell projecting sufficiently for two of the shells being used not being able to fit through the correctly sized collar.

This fault had been made worse as a result of Cardox increasing the wall thickness of the shell so that the overall external diameter had increased by 1mm, which was not known to the users.

The larger internal sized collar had been used with the smaller external diameter shells for some time prior to the incident because of the slight increase in diameter, the welding ridges and that some lateral movement was possible when inserting the cardox shell through the collar and into the calciner prior to detonation.

Both larger diameter collars removed from use and returned to Cardox.

Smaller diameter collars reamed to accommodate the slight increase in external diameter of the cardox shells.

Defective shells machined to remove ridges – Cardox reviewed their quality control procedures to ensure that defective shells cannot be issued in future.
