# Cardox Shell Incident

**CEMENT PLANT**  
**PRODUCTION AND PROCESSING**  
**CEMENT PRODUCTION**

**ALERT STATUS:** Normal  
**DATE ISSUED:** 04/12/2012  
**INCIDENT No:** 00347

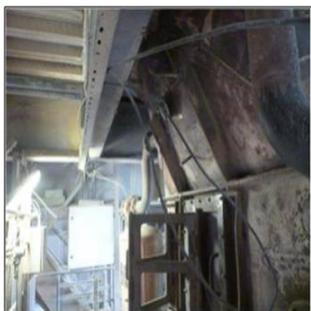
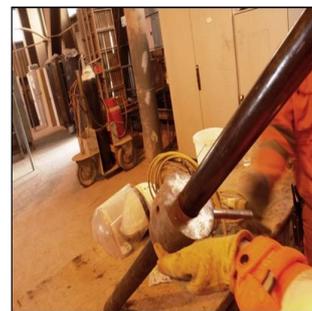
During routine cardox use, a shell was ejected from the retaining collar striking a hand rail and resulting in minor damage to a water pipe.

The shell has a slightly raised shoulder at one end which has a larger external diameter than the internal diameter of the centre of the collar. This prevents the shell from being ejected from the calciner when detonated – provided that the correctly sized collar is used.

Two sizes of retaining collar were available for use, the larger internal sized collar was being used with the smaller diameter shell.

A manufacturing defect had resulted in ridges at the welded seam of the shell projecting sufficiently for two of the shells being used not being able to fit

for two of the shells being used not being able to fit through the correctly sized collar.

This fault had been made worse as a result of Cardox increasing the wall thickness of the shell so that the overall external diameter had increased by 1mm, which was not known to the users.

The larger internal sized collar had been used with the smaller external diameter shells for some time prior to the incident because of the slight increase in diameter, the welding ridges and that some lateral movement was possible when inserting the cardox shell through the collar and into the calciner prior to detonation.

Both larger diameter collars removed from use and returned to Cardox.

Smaller diameter collars reamed to accommodate the slight increase in external diameter of the cardox shells.

Defective shells machined to remove ridges – Cardox reviewed their quality control procedures to ensure that defective shells cannot be issued in future.
