# INCIDENT ALERT

<b>LOCATION:</b>	<b>ASPHALT/COATING PLANT</b>	<b>ALERT STATUS:</b>	<b>Normal</b>
<b>ACTIVITY:</b>	<b>MAINTENANCE &amp; HOUSEKEEPING</b>	<b>DATE ISSUED:</b>	<b>02/10/2020 10:20:24</b>
<b>SUB ACTIVITY:</b>	<b>N/A</b>	<b>INCIDENT No:</b>	<b>02569</b>

**Stored Energy Incident - Resulting in a Major LIFE CHANGING Injury**

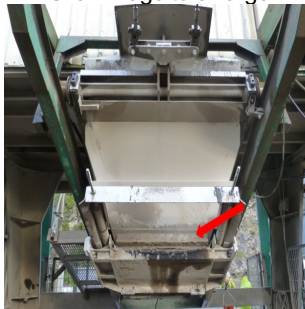
The skip door (which was under immense stored energy from the tension in the springs, in the open position) closed whilst the fitter was partially inside the door frame with such force it suspended him by the left forearm. With the task not being risk assessed and in particular how the door mechanism operated they had not established that it posed a serious risk.

- Re-enforce LOTOTO process and consider potential stored energy such as springs under tension in this case, known abnormal situation as the door being stuck open.

- Interlocked key system on the access gates had been employed, however this does not provide power isolation to other areas of the plant including the mixer, mixer doors and associated equipment directly above the skip area, which could affect any work carried out below the mixer.
