## INCIDENT ALERT

**Operator bruises hand due to release of stored energy in operation to free stuck davit (lifting device) - BMAPA Alert**

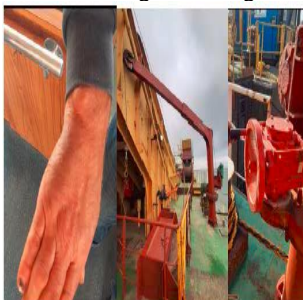
While moving a stuck lifting davit which was wedged under a fire main pipe with the use of a chain block onboard a UK marine aggregate dredger, the slewing wheel hit the IP's hand causing bruising when the davit arm released.

To free the boom of the davit a chain block was rigged so the boom would be pulled downward and outward. While the boom was loaded up by the chain block the boom came free from under the pipe and moved suddenly outboard. At this point the slewing wheel spun round where upon the handle of the wheel struck the IP on the back of the hand.

Prior to this incident the discharge boom was moved past its normal operating parameters at a wharf to facilitate discharge. The hazards involved had not been clearly identified as the boom conveyor struck the davit and pushed the davit underneath the fire main where it became stuck. No formal Risk Assessments were in place for either the movement of the discharge boom to facilitate discharge beyond normal operating parameters, or the subsequent freeing of the davit back into its normal position.

- When conducting Risk Assessments ensure all hazards are clearly identified especially when identifying the potential of stored energy being present.
- Any operational equipment being moved beyond its normal operating parameters must be fully risk assessed and approved by the Ship Manager beforehand, except if for "preservation of life", the ship or the environment under the master's discretion.
