Operator bruises hand due to release of stored energy in operation to free stuck davit (lifting device) - BMAPA Alert

ALERT STATUS: Normal
DATE ISSUED: 06/10/2020 10:33:40
INCIDENT No: 03570

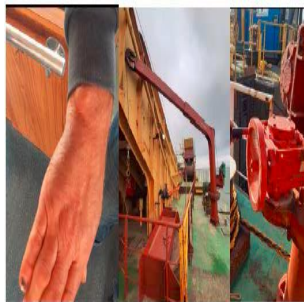
While moving a stuck lifting davit which was wedged under a fire main pipe with the use of a chain block onboard a UK marine aggregate dredger, the slewing wheel hit the IP's hand causing bruising when the davit arm released.

To free the boom of the davit a chain block was rigged so the boom would be pulled downward and outward. While the boom was loaded up by the chain block the boom came free from under the pipe and moved suddenly outboard. At this point the slewing wheel spun round where upon the handle of the wheel struck the IP on the back of the hand.

Prior to this incident the discharge boom was moved past its normal operating parameters at a wharf to facilitate discharge. The hazards involved had not been clearly identified as the boom conveyor struck the davit and pushed the davit underneath the fire main where it became stuck. No formal Risk Assessments were in place for either the movement of the discharge boom to facilitate discharge beyond normal operating parameters, or the subsequent freeing of the davit back into its normal position.

A formal RA may have identified the potential of hitting the davit in the first place and subsequently the release of stored energy when the boom was released by the chain block.

The POWRA must only be used for low risk tasks and there was sufficient time to plan and complete the RA for the movement of the davit which occurred 4 days after it was wedged under the fire main.

- When conducting Risk Assessments ensure all hazards are clearly identified especially when identifying the potential of stored energy being present.
- Any operational equipment being moved beyond its normal operating parameters must be fully risk assessed and approved by the Ship Manager beforehand, except if for "preservation of life", the ship or the environment under the master's discretion.
