# Fatal 1 - BMAPA Alert - Stored energy/Stress in a damaged hull

<b>LOCATION:</b>	<b>AGGREGATE DREDGER</b>	<b>ALERT STATUS:</b>	<b>Normal</b>
<b>ACTIVITY:</b>	<b>MAINTENANCE &amp; HOUSEKEEPING</b>	<b>DATE ISSUED:</b>	<b>30/10/2020 11:16:10</b>
<b>SUB ACTIVITY:</b>	<b>N/A</b>	<b>INCIDENT No:</b>	<b>03573</b>

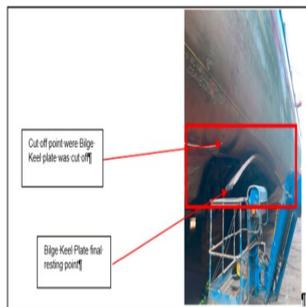
A contractor working in a UK ship repair yard was removing a section of damaged bilge keel by oxy acetylene burning. When reaching the end of his cut the stored energy / stress in the deformed bilge keel caused the plate to release downwards then upwards violently hitting the contractor on the chest, shoulder, jaw and head.

Fortunately, this did not end up with any life changing major injuries but it could have and it was completely avoidable if a task specific risk assessment had been completed.

- All tasks in a repair yard should be fully risk assessed to identify all risks present and not presume or assume personnel (including contractors/sub-contractors) understand all risks associated with tasks.

- Personnel are required to sign off the risk assessment for the task to confirm they have read and understood.
- Repair yards to ensure they have risk assessments in place for “Removing Material under stored energy”

- One-to-one briefing of workers by supervisor or manager to ensure they understand the method statement and associated risk controls.
- Any potential stored energy release tasks must be classed as high risk

- Specific control points are to be put in place to remove damaged hull plating in small sections with all plating / frames under stress marked up with cut lines / cut sequence

- Any plate being removed must be supported / restrained to control any release of stored energy
- Daily project meetings must ensure all high-risk activities are discussed and all associated work is properly planned.
