# Operator sustains grazed/bruised back from contact with scaffolding -non-treatment injury - BMAPA Alert

**LOCATION:** AGGREGATE DREDGER  
**ACTIVITY:** ACCESS & EGRESS & WORKING AT HEIGHT  
**SUB ACTIVITY:** N/A

**ALERT STATUS:** Normal  
**DATE ISSUED:** 03/12/2020 12:28:45  
**INCIDENT No:** 03577

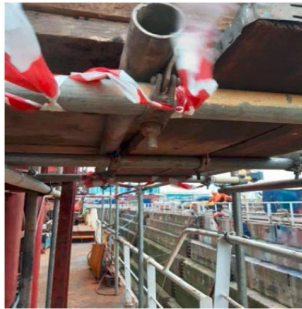
A UK marine aggregate dredger was undergoing its annual dry dock. Scaffolding had been erected in the vicinity of the aft screening tower to facilitate its removal. The scaffolding was erected across the starboard side walkway which restricted the walkway, with the scaffolding platform only being 1.5m above the spillway. The erected scaffolding had red and white hazard tape applied to highlight the low height of the scaffolding and the protruding scaffolding clips whilst waiting on delivery of protective foam.

The IP transited this walkway for general access to the engine room and in doing so, whilst crouched down, impacted his back on the protruding scaffolding clips. This caused a small abrasion and bruise on the left side under the shoulder.

It has been identified that there was inattention to immediate surroundings as the scaffolding was highlighted with hazard tape.

- Staff to discuss the importance of paying attention to their immediate surroundings and the importance of making informed decisions where normal access routes may be restricted during maintenance periods.
- Ensure scaffolding has been fully completed, including foam protection fitted before signed off and used as a thoroughfare.
