INCIDENT ALERT

LOCATION:	AGGREGATE DREDGER	ALERT STATUS:	Normal
ACTIVITY:	MAINTENANCE & HOUSEKEEPING	DATE ISSUED:	07/01/2021 17:58:55
SUB ACTIVITY:	N/A	INCIDENT No:	03581

Fatal 6 - Stored energy medical treatment injury - BMAPA Alert

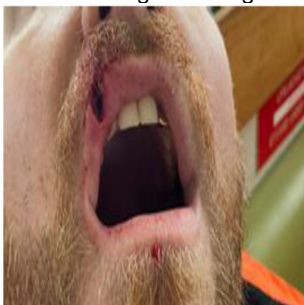
A conveyor belt contractor working onboard a UK marine aggregate dredger was engaged in turning the longitudinal belt which had flipped during operation. During the task the turfor clamp/hook became "stuck" between the conveyor frame and the rubber conveyor belt, the contractor then gave the chain to which the clamp/hook was connected a tug.

The clamp/hook freed more easily than he expected and as the IP was standing directly beneath the hook and was pulling the chain towards himself it contacted his right upper lip.

A second contractor, who was working above the IP and close to the stuck hook could have assisted with the freeing of the hook but wasn't asked to help or identify the reason for the hook being stuck.

- Risk Assessments for working on conveyor belts must be reviewed and consider the hazard of being struck by moving object/tools when fastening and removing turfors from a clamped position.
- Ensure close supervision and staff adopt a safe method of working as it will be specific to the location and tools in use.
