Fatal 5 – Employee sustains face injuries whilst assisting in the movement of a suspended load with a telehandler.

LOCATION:	WHARF	ALERT STATUS:	Normal
ACTIVITY:	LIFTING	DATE ISSUED:	29/11/2023 10:15:26
SUB ACTIVITY:	NO SUB ACTIVITY AVAILABLE	INCIDENT No:	03677

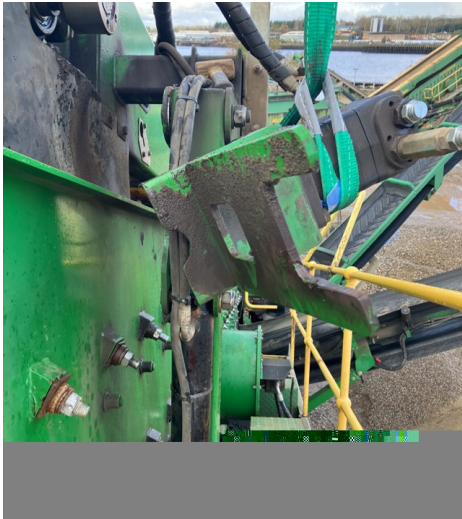
The foreman had been advised to get assistance from a site operative. The weight of the motor was supported by a telehandler. The incident occurred when the final bolt was released from the motor. As the motor was pulled back, it snagged on the torque plate brace. The operative tried to release the snag and the motor freed and then, because it was attached to strops suspended from the telehandler, it rotated anti clockwise hitting the operative's safety helmet, which pushed into his forehead causing a laceration. The motor continued to rotate, with the torque plate striking the right-hand side of the operative's nose. He was taken to hospital where he required 3 stitches.

Image of motor suspended

- Specific RAMS and Lift Plan should have been in place to identify the most appropriate method of work, and ensure when the task didn't go to plan, it was stopped allowing the RAMS and Take 5 to be reviewed.
- The weight of the motor was being supported by a strop wrapped around the motor attached to the telehandler. The foreman operating the telehandler and operative were communicating through an open window. Use of a Hiab may have improved communication and allowed the person guiding the lift to stand on the work platform; alternatively, use of a pull lift would have provided greater control of the tension placed on the motor.
- Rather than attempting to release the motor by hand, use of a guide rope would have avoided the need to be "in the line of fire".
