# Eye injury whilst sampling concrete

LOCATION: READYMIX OR MORTAR PLANT  
ACTIVITY: PRODUCTION AND PROCESSING  
SUB ACTIVITY: READYMIX

ALERT STATUS: Normal  
DATE ISSUED: 23/02/2022 11:06:20  
INCIDENT No: 03607

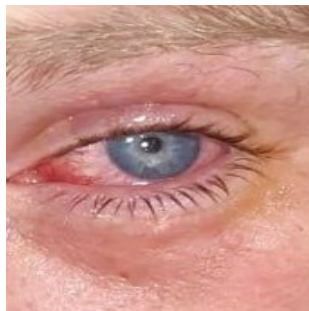
The technician's usual wheelbarrow for sampling had previously been used for the same load and was full of material. Therefore, a bucket was positioned beneath the truckmixer chute in order to take the sample, extensions were not added to the chute. The driver was unaware of the flowing nature of the material and, when operating the discharge controls, the concrete poured rapidly into the bucket. Due to the Technician's positioning, he was in the line of fire and concrete splashed into his face, getting behind his safety glasses.

The technician suffered a scratched eye, which resulted in him having to carry out restricted work duties for a short period.

Review of incident identified the following key findings

- Incorrect equipment used for sampling.
- Technician positioned in line of fire.
- To reduce interactions during the pandemic sampling procedures were changed, this change resulted in alterations to usual working practices.
- Driver was unaware of product properties

- Carry out point of work risk assessment before a task and whenever a change occurs
- Fully inform others in working area of potential hazards
- Select correct PPE for task. Goggles may be more appropriate than safety glasses for some tasks.
