# Fatal 1 - Conveyor entrapment

**LOCATION:** RECYCLING PLANT  
**ACTIVITY:** GUARDING AND ISOLATION  
**SUB ACTIVITY:** NO SUB ACTIVITY AVAILABLE

**ALERT STATUS:** High Potential  
**DATE ISSUED:** 22/03/2022 12:14:04  
**INCIDENT No:** 03611

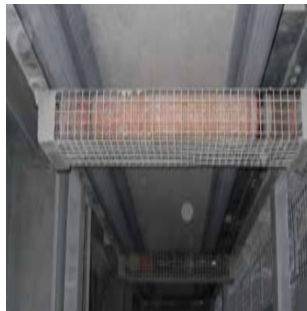
Basket Guard

The conveyor is approximately five years old and had been designed and built to BS EN 620 2002 and A1 2010. The design was that the return idlers were fitted with a basket guard similar to the illustration shown (Guarding of Machinery Guidance from the Quarry Products Association Aug 2005).

The issue is that the basket guard alone may just move the in running nip point from the idler to the edge of the guard, hence the need for these additional measures.

- Ensure restricted access via zoning for belts below 2700mm,
- Fit idlers with basket guards
- Restrict access under belting with handrailing and signage or additional guarding, up to 2700mm
- Check gap between conveyor and basket guard, which must be less than 5mm.
- Survey belt deflection near basket guards for 50mm deflection with less than 150N force.
