# Fire – Dredger drive step-up high voltage transformer

**AGGREGATE DREDGER**

**03622**

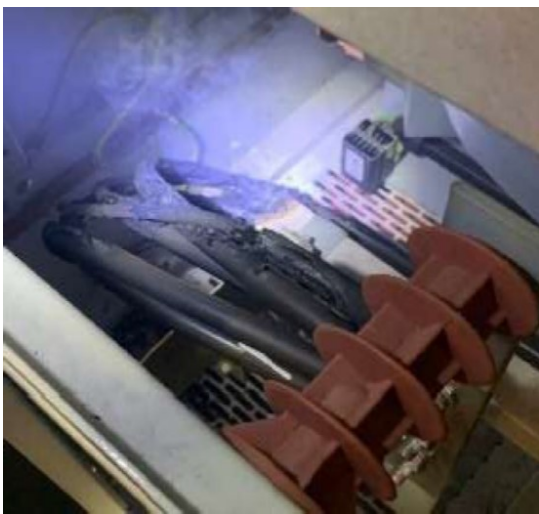
A UK marine aggregate dredger was 2-hours into its regular dredging operation when a fire alarm sounded on the bridge activated by a detector in zone 8 which covered a number of compartments. Activation was due to smoke being generated by smouldering electrical cable cores within the pump drive step-up voltage transformer located in the pump-motor room within fire detection Zone 8.

The smouldering cables were successfully extinguished by the ships crew using portable CO<sub>2</sub> extinguishers, with no injuries to personnel and no damage to the transformer or any other equipment.

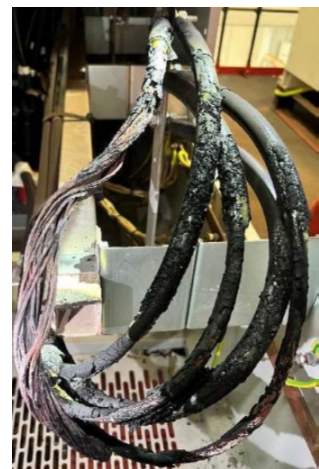
The cable routing and attachment to the framing gave rise to chaffing of the cable core insulation at the bend radius (probably caused by vessel vibration), allowing the conductors to be exposed, generating heat leading to further deterioration of the cable core insulation. All other cabling and terminal connections were found to be in good order.

- Improved routing of the cable cores and protection of likely chaffing points.
