# Fatal 5 - Excavator struck by falling rock

## WHAT HAPPENED

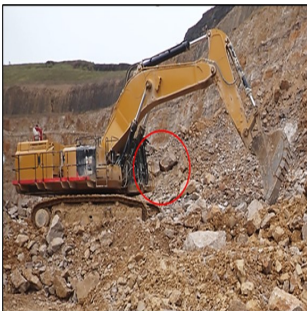
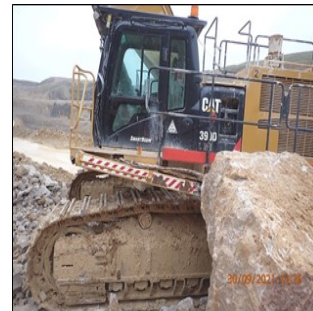
During face loadout operation at a hard rock quarry, a large piece of stone (weighing approximately 6 tonnes) toppled a short distance from the side of the blast-pile and struck the nearside of a CAT 390 excavator, causing damage to the machine's retractable access steps. No one was hurt in the incident.

- Although there was a suitable rock trap in front of the machine the rock trap at the nearside of the machine was not sufficient to contain the piece of rock.
- The excavator operator was very experienced and fully qualified having had formal face excavator and geotechnical training – he had operated front line face machinery for many years.

- In accordance with QNJAC guidance, operators must ensure that; “there is a suitably designed rock trap in place, which as a rule of thumb should be  $\frac{2}{3}$  of the face height in depth and  $\frac{1}{4}$  of the face height in width” to capture and contain any rocks that fall from the face / blast pile during load out.

- The task specific E&T job cards are to be reviewed and reissued to all face operatives, along with re-training, to ensure safe working requirements are clearly understood and complied with at all times.
