Fatal 5 - Excavator struck by falling rock

QUARRY

03624

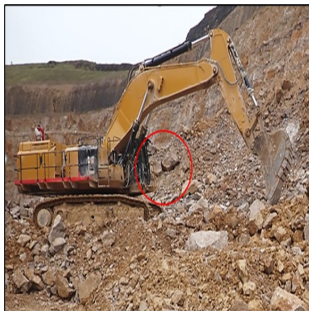
During face loadout operation at a hard rock quarry, a large piece of stone (weighing approximately 6 tonnes) toppled a short distance from the side of the blast-pile and struck the nearside of a CAT 390 excavator, causing damage to the machine's retractable access steps. No one was hurt in the incident.

- Although there was a suitable rock trap in front of the machine the rock trap at the nearside of the machine was not sufficient to contain the piece of rock.
- The excavator operator was very experienced and fully qualified having had formal face excavator and geotechnical training – he had operated front line face machinery for many years.

- In accordance with QNJAC guidance, operators must ensure that; “there is a suitably designed rock trap in place, which as a rule of thumb should be $\frac{1}{2}$ of the face height in depth and $\frac{1}{4}$ of the face height in width” to capture and contain any rocks that fall from the face / blast pile during load out.

- The task specific E&T job cards are to be reviewed and reissued to all face operatives, along with re-training, to ensure safe working requirements are clearly understood and complied with at all times.

- If you are unable to comply with standard safe working practices ‘STOP THE JOB’ and speak to your supervisor or line manager to discuss and review the safest way forward.
