# Fatal 6 - Spinflow Tipper Rollover

**ALERT STATUS:** High Potential  
**DATE ISSUED:** 09/01/2023 14:38:17  
**INCIDENT No:** 03632

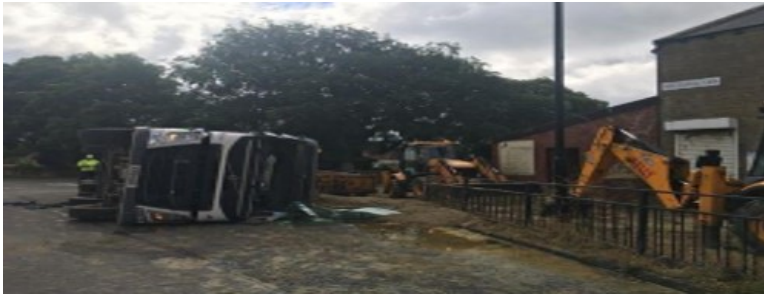
A Spinflow Tipper truck carrying 6m<sup>3</sup> of Ready To Use Mortar rolled over when travelling round a roundabout. After missing a customer site entrance, the driver had to go to the next roundabout to do a full U-turn in order to gain access to the customer site; footage shows him not reducing speed as he approached the roundabout. A combination of speeding and the fluid material carried caused the vehicle to tip over when travelling round the roundabout. The driver was wearing a seatbelt and no loose objects were in the cab, so fortunately he was not injured but was badly shaken. No members of the public were involved, but it did cause traffic delays in the area and resulted in a large scale clean up operation

- The driver was employed by an Independent Haulage Contractor (IHC) and had 4 days training before been allowed to drive on his own
- The driver had 5 years driving experience, but not with Readymix products or vehicles
- The IHC did not notify the Operations team of the new starter and therefore had not received the company's Driver Induction
- Footage shows the driver did not adjust his speed for the road conditions and the road layout
- MP Connect system was not used to check base drivers
- The driver was wearing a seatbelt and no loose items were in the cab

- The IHC Should have notified the operations team of the new driver, so he could be inducted and reviewed for competence
- Had the depot used the MP Connect sign-in, they would have known about the new driver
- All drivers should drive below the limit and adjust speed to suit vehicle type, loading, weather and road conditions

- Ensure all new drivers receive the company driver induction and review competence for specific vehicle types
- Carry out regular Driver VFLs
- Review MP Connect system process to include base drivers
- Review IHCs Training policy and sign off
