# Tyre Fitter Entrapment

## WHAT HAPPENED

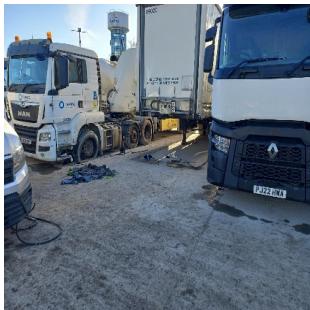
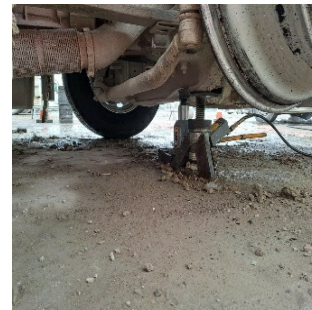
The image shows the tractor unit the tyre fitter was working on. The fitter became trapped under the steps of the unit when it appears that the jack, he was using to lift the unit to change the tyre failed or became dislodged (the company is still waiting for the completion of the investigation).

Wheel chocks and secondary axle supports should have been installed as part of the works but were not. The wheel chocks are used to prevent truck movement during works and the secondary supports are used to support the unit should a jack fail or become dislodged.

- The IP did not use either secondary axle supports or wheel chocks during their work. These requirements were part of the method statement. On investigation secondary supports were found to be within the fitters van, wheel chocks could not be found in the van.
- The IP had used an access code to get through gates that provided security to the site, failed to call security when at the gate, failed to report to the weighbridge as would be the norm, drove to the HGV trailer park within the site and commenced works.
- They did not notify anyone of their arrival (investigations continue as to how the fitter got the access code but current investigations identify this was not given to them by the company)

- Please use this briefing as an awareness piece, identifying to those who manage contractors the key controls identified to be used when a vehicle is lifted by jack for maintenance works.
- Following the incident take opportunity to review access and egress points to your sites to ensure secure and managed as is reasonably practicable.
