Angle Grinder Kick Back

CEMENT PLANT
MAINTENANCE & HOUSEKEEPING
N/A

ALERT STATUS: **Normal**
DATE ISSUED: **24/04/2013**
INCIDENT No: **00364**

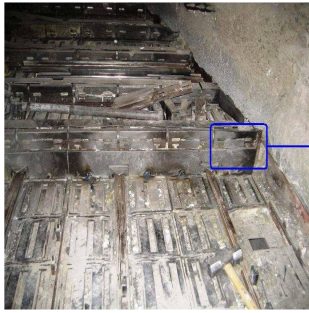
An experienced operator was using a 9 inch angle grinder to cut out lower stainless steel welding fillets in the clinker cooler.

Fillet Being Cut

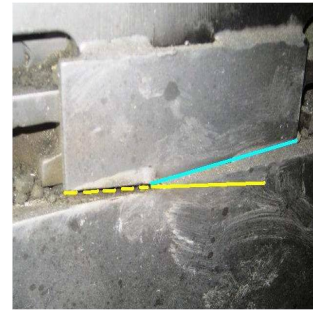
Cut Out of Alignment

used in a near vertical position where a consistent even cut through the stainless steel welds was possible. Therefore the machine was used in a more horizontal plane which resulted in an off-horizontal cut, that in turn resulted in the blade snagging and kicking back.

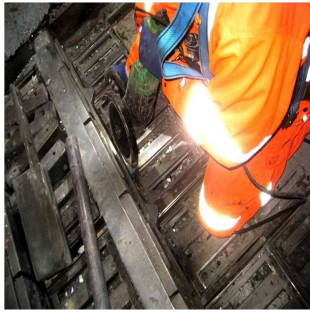
As the operator approached the cooler wall he couldn't operate the grinder vertically, so moved to position where he was using it by holding the grinder horizontally. In order to access the last two welds he remained standing but stooped in order to hold the angle grinder in a more horizontal plane as the previously steeply inclined position could not be accommodated so close to the cooler wall.

There was insufficient space available close to the cooler wall to allow the 9 inch angle grinder to be

Cutting Position

The use of 9 inch angle grinders was suspended until a full evaluation of the need to use this type of equipment has been made (and further 4½ inch angle grinders were sourced).

Subsequently if there is a call for the use of a 9 inch angle grinder, then a task specific risk assessment must be completed: and the 9 inch angle grinder will only be permitted for the use of that operation only.

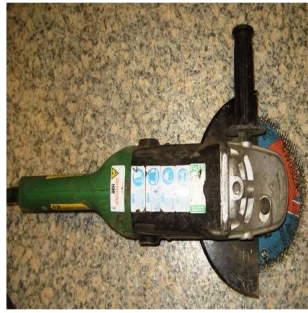
During the use of the grinder horizontally, the blade snagged in the steel being cut and kicked back towards the user. As the grinder kicked back the rotating blade caught his left thigh, resulting in a laceration about 60mm in length and 25mm deep, that required immediate first aid and hospital treatment.

Recovered Grinder
