# Fatal 1 - Failure to properly isolate agitators at block plant during maintenance work

LOCATION: CONCRETE PRODUCTS PLANT  
ACTIVITY: GUARDING AND ISOLATION  
SUB ACTIVITY: NO SUB ACTIVITY AVAILABLE

ALERT STATUS: Normal  
DATE ISSUED: 22/06/2023 12:47:56  
INCIDENT No: 03645

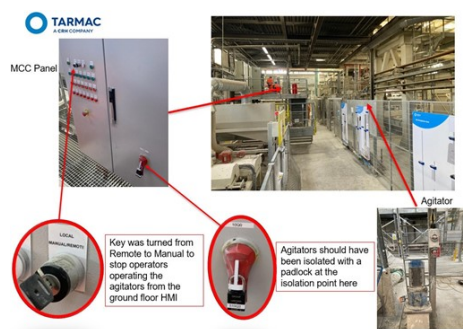
During a yearly shutdown in April 2022 at a block plant, work was planned to be carried out by the operators to dig out the vac crust pit located under the vac and cutting line. Operators had taken out the castell key to enter the vac area and put into the lock box. All the operators individually locked off to the box securing the area to work in, they then entered the area and began to dig out the crust pit. While carrying out a walk of the area, a safety rep and maintenance manager identified the agitators within the area were switched off (To "Manual") on the MCC panel on the mezzanine floor but the panel was not fully isolated, and no isolation document had been completed.

Although a LOTOTO SOP for this task was present and clear, including all the isolation points, the responsible person had failed to own the isolation process and to make sure all the measures were in place before the work commenced.

- Share this incident with all sites
- Review site isolation process and training in line with company standard, and site shut down procedure.
- Find engineering solutions to simplify the isolation process in line with best practice.
