INCIDENT ALERT

Normal
31/07/2013
00366

Wheel Rim Failure

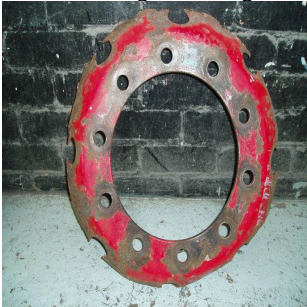
Wheel Flange

The wheel was manufactured in 1998, so was approximately 15 years old. The wheel also had significant corrosion on, and around the weld that joins the wheel flange to the wheel rim.

An immediate fleet survey took place, and any wheels showing signs of corrosion on or around the weld, were replaced.

As wheels are date stamped the second phase is to replace any wheel that is over 10 years old regardless of condition.

Please be vigilant when inspecting wheels, and report/replace any that show signs of corrosion on or around the weld.

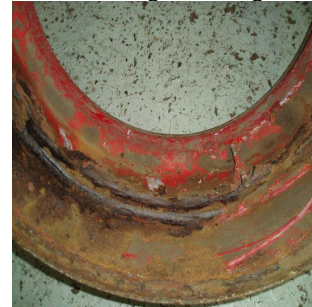
Wheel Rim

A packed trailer had been loaded in the packing bay, and was proceeding to be parked up on site, when the O/S rear axle wheel failed and became detached from the vehicle.
