TRANSPORT - Fatal 2 - Dumper Truck loses wheel

LOCATION: QUARRY
ACTIVITY: PEDESTRIAN AND TRANSPORT SAFETY ON-SITE
SUB ACTIVITY: NO SUB ACTIVITY AVAILABLE

ALERT STATUS: Normal
DATE ISSUED: 20/09/2023 10:58:03
INCIDENT No: 03668

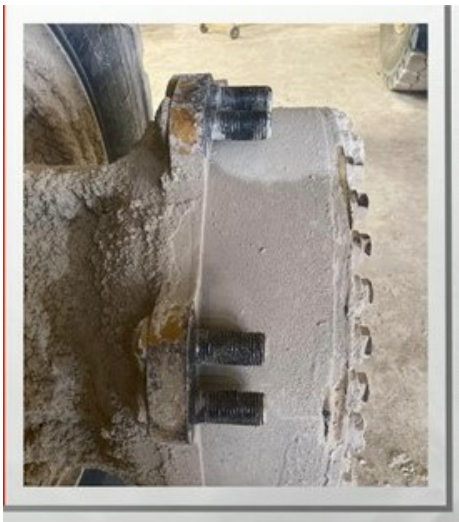
A 1.2 tonne wheel came off a dump truck, the incident was captured on video. Thankfully, nobody was injured.

- R&M contractors were responsible for maintenance of the mobile equipment, but not the tyres.
- It has been suggested that the wheel nuts had become loose and when the dumper turned, the weight transfer caused the last few threads to strip out; the photo on the video show limestone build in the threads and stretching / stripping of the threads.
- This would indicate that the wheel had been removed recently, but there is no record of this.

- Are traffic management plans designed to minimise risks from the likes of vehicle runaway or overturn, with suitable gradient, bunds, pedestrian exclusion zones etc?
- Where R&M contractors are engaged, do you have access to inspection, defect and repair records. Are they monitored appropriately?
- Are machine operators trained and competent to carry out the full range of inspections and checks expected of them, and is competence assessed? This maybe particularly relevant for new, more inexperienced operators.
- Do you have formal policies / procedures to ensure the torque of wheel nuts is checked at the required intervals by a competent person after a wheel has been refitted, with records being maintained.
