# TRANSPORT – Fatal 6 - Tipper lorry roll over during the unloading of a bulk fuel material

| LOCATION: | LIME & SLAG PLANTS | ALERT STATUS: | Normal |
| SUB ACTIVITY: | DELIVERING FUELS & LUBRICANTS | INCIDENT No: | 03680 |

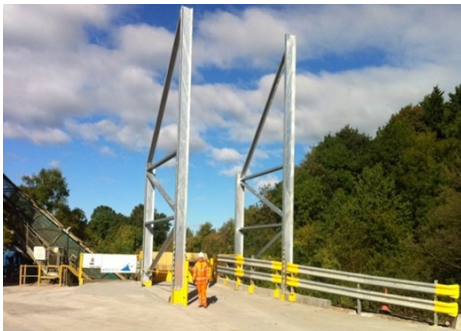
### 3. Use of structures that prevent overturns see image below typical structure
