# TRANSPORT – Driver sprains hand whilst attempting to clear stuck material from tipper

**LOCATION:** CONSTRUCTION/DELIVERY SITE  
**ACTIVITY:** TRANSPORT & LOGISTICS / DELIVERY  
**SUB ACTIVITY:** DELIVERING AGGREGATES

**ALERT STATUS:** Normal  
**DATE ISSUED:** 26/02/2024 12:07:06  
**INCIDENT No:** 03698

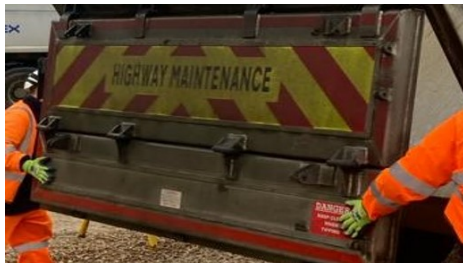
A company tipper driver had finished tipping a load at a customer site and, on checking the vehicle body camera, saw a small amount of frozen product still in the rear. The material covered the steps inside the vehicle body making it unsafe to gain access. With the tipper body still raised, the driver went to the rear of the vehicle and attempted to remove the material by swinging the tailboard against the vehicle body using the palm of their left hand. After one attempt an employee of the customer joined the driver, and they struck the tailboard twice more. Some of the product was dislodged and the driver then swept off the tailboard. On walking back to the vehicle cab, the driver felt a pain in their left hand and on the journey back to the quarry the hand started to swell. The driver was taken to hospital and was diagnosed with a sprained left hand.

The image below shows the position of the drivers hand - on the right hand side on the warning notice.

**Process** - The driver correctly identified the risks of entering the vehicle body in icy conditions, but then failed to follow the SSOW and attempted an unsafe procedure to remove the material.

By not attempting to remove the product after assessing it was unsafe to enter the vehicle body and following the correct SSOW process, which was to report back to the Driver Supervisor for further instruction.

- Ensure all drivers are aware of the correct SSOW process to follow when product is stuck in the vehicle body.
- The product left in the body was a small amount, and the driver's next load was the same product so the vehicle could have left site without trying to dislodge it.
