Fatal 3 - The faulty installation of a fall protect system on a chimney ladder had put operators at risk until error was picked up during inspection

LOCATION: CEMENT PLANT
ACTIVITY: ACCESS & EGRESS & WORKING AT HEIGHT
SUB ACTIVITY: N/A

ALERT STATUS: High Potential
DATE ISSUED: 29/05/2024 12:56:44
INCIDENT No: 03712

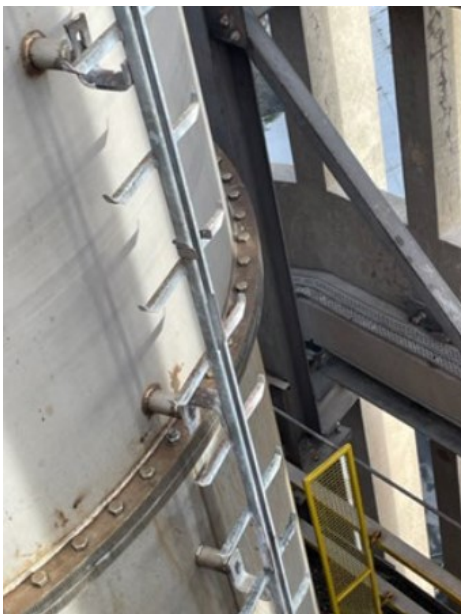
A chimney access ladder had an inbuilt rail to allow a person to attach a fall protection harness. During a recent inspection of the chimney, it was discovered that the first 5 metre section of the ladder had been installed upside down.

As a result of the faulty installation, the slot in the rail where a person would normally insert their lanyard was 4 metres above ground level instead of 4 feet as it should be. However, it was still possible to clip onto the rail at the bottom of the ladder by inserting the clip into the open end of the rail. The consequence of this is that people have been using the system for several years unaware of the installation defect. It was possible that, as they passed the slot in the rail 4 metres above the ground, their lanyard could fall out of the rail without them noticing, leaving them with no fall protection as they climbed the chimney.

The chimney ladder with the integral fall protection rail was installed by a contractor who was not a registered or trained installer of this bespoke safety system.

The image below shows the ladder, the section where a lanyard could fall from the rail can be seen around the middle of the picture.

- Bespoke safety systems should always be installed (or moved to a new location) by companies that are trained / registered installers.
