Fatal 5 - A silt retaining wall collapses at wharf

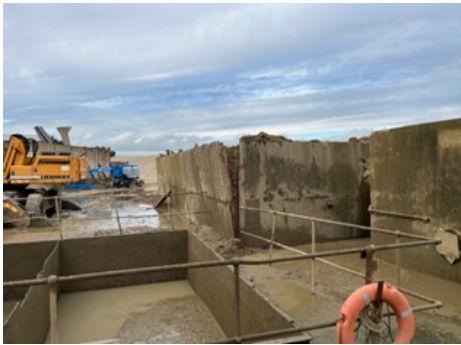
The initial investigation has highlighted that structural defects with the wall had been identified in all previous structural assessments from 2019 as requiring replacement. These had not yet been completed. The image below was extracted from the last structural survey which had taken place in 2023.

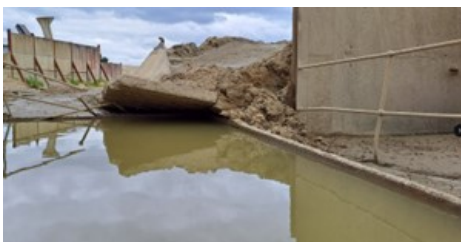
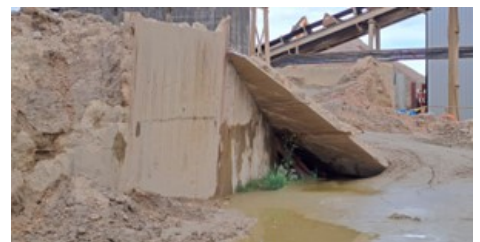
The incident occurred at an aggregates wharf in May 2024. The concrete retaining wall was used for retaining wet silt. The incident occurred in the morning after some additional material had been added to the stockpile. An hour later the concrete retaining wall collapsed, the wall struck the edge protection around the area allowing silt to flow out of the stockpile area. No material left site or obstructed any walkways. The area was cordoned off to allow an investigation to take place.

The images below show the concrete wall structural collapse and damage to edge protection to silt bays May 2024

This incident highlighted the importance of checking structural surveys and the related processes associated with the management of surveys.

- Have you completed all required actions, including observations with recommended actions?
- If issues are found, discuss with your regional engineer to ensure they are assessed by a competent person on a regular basis in line with your Structural Inspection Standard.
- Referring to Stockpiles, Excavations and Tips. Do your rules include the capacity for all the volume and type of material you intend to store on site?
- Ensure appointments and associated forms such as weekly/month inspections scheduled are completed;
- Discuss with your Geological Team member and update your system with any findings that you discover regarding stockpile designs.
