Fatal 5 - Fitters foot trapped under a beam as it was lowered

LOCATION: CONCRETE PRODUCTS PLANT
ACTIVITY: LIFTING
SUB ACTIVITY: NO SUB ACTIVITY AVAILABLE

ALERT STATUS: Normal
DATE ISSUED: 15/07/2024 11:50:14
INCIDENT No: 03725

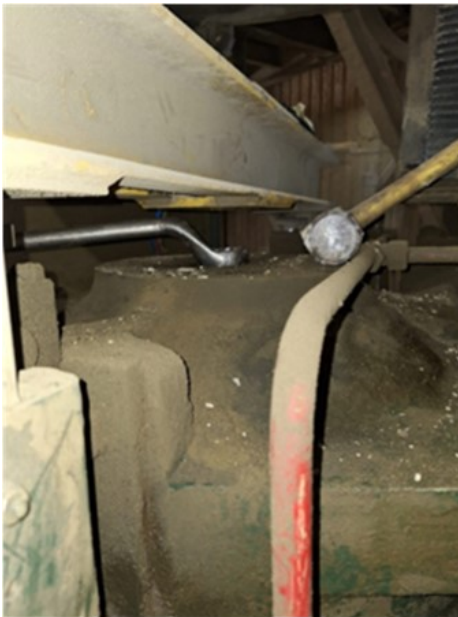
During the service on a press, a fork lift truck (FLT) driver lowered a section of the plant back into the machine and trapped the foot of a fitter causing severe bruising which resulted in an LTI. The image below shows the area where the fitter's foot, which had been securing a spanner, was trapped between the beam being lowered and the press.□

The fitter was located within the press housing, carrying out the maintenance task and monitoring the lowering of the plant section to ensure that it remained straight. The FLT driver could not tell whether the beam was straight from his position in the cab.

A miscommunication between the FLT driver and fitter led to the section of plant being lowered and trapping the foot of the fitter. The fitter's foot was severely bruised. Although a point of work risk assessment had been completed it did not recognise entrapment as a hazard.

- Ensure all lifting operations are properly planned <https://www.hse.gov.uk/work-equipment-machinery/planning-organising-lifting-operations.htm>
- Check availability of required equipment and that it is not booked for another task when required.
- Only personnel required for the lift should be in the lifting zone and robust communication systems should be in place between all involved.
