# A maintenance inspection of bitumen tank uncovers severe corrosion at base of tank

LOCATION:	ASPHALT/COATING PLANT
ACTIVITY:	MAINTENANCE & HOUSEKEEPING
SUB ACTIVITY:	ASPHALT & COATED STONE

ALERT STATUS:	High Potential
DATE ISSUED:	19/08/2024 15:45:04
INCIDENT No:	03729

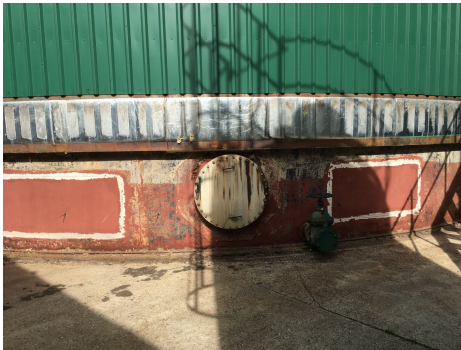
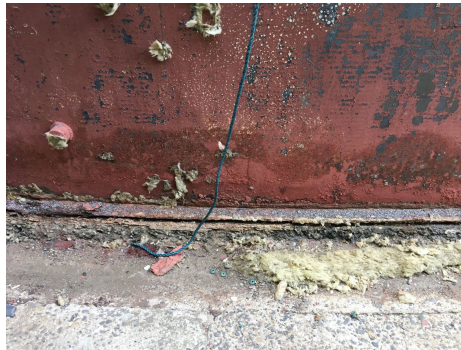
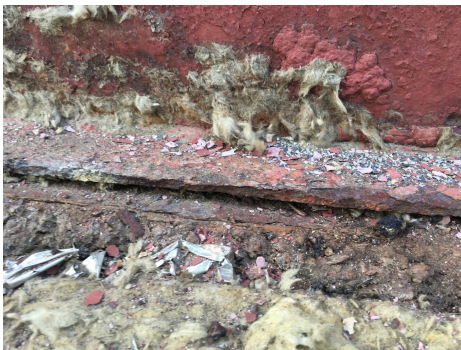
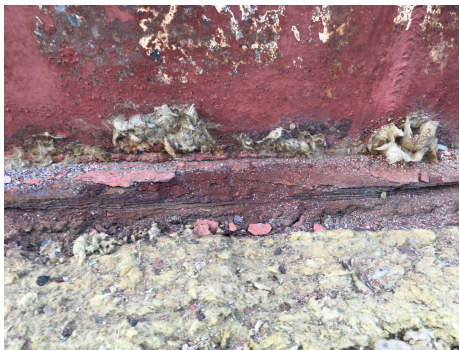
Significant corrosion was discovered at on the steel at the base of the tank walls and further inspection revealed that the thickness of the tank wall had decreased by 75%.

This was due to moisture ingress into the insulation of the tank, with the combination of heat, water and oxygen causing significant corrosion. The images below show the corrosion at the base of the tank.

There are two possible actions to mitigate the effects of moisture on the tank walls:

- Removal of insulation from the base of the tank (100-150mm)
- Incorporation of stainless steel, rather than mild steel for the bottom 1.5m of the tank walls.
