INCIDENT ALERT

ALERT STATUS: Normal
DATE ISSUED: 20/12/2013 06:45:53
INCIDENT No: 00373

Failure of CMC Aerial Platforms - UV145 MEWP Boom

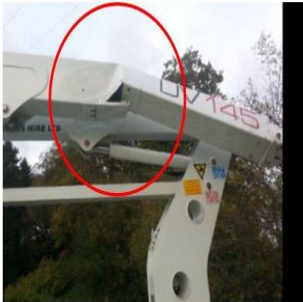
An overhead line team were working from a Mobile Elevated Work Platform (MEWP) when the main boom (arm) of the device failed. This resulted in the platform dropping and twisting through 45 degrees. The operatives working from the platform were fully attached and no injuries were sustained.

The type of vehicle that the platform was mounted on is simply an example; investigations have shown that the failure was due to a manufacturing defect which has been found on similar MEWPs.

MEWP Failure

Everyone: Look out for CMC MEWPs in your work environment. If you identify this type of MEWP on your site you must not use it and report it to your Supervisor.

If you have hired a MEWP for your site ensure it is not manufactured by CMC. It is recommended that any CMC MEWP should be returned to the hire company

If you own this type of platform contact CMC direct immediately for further advice
