Explosion in a High Voltage Substation

CEMENT PLANT
PRODUCTION AND PROCESSING
CEMENT PRODUCTION

ALERT STATUS: Normal
DATE ISSUED: 08/02/2014 13:50:00
INCIDENT No: 00374

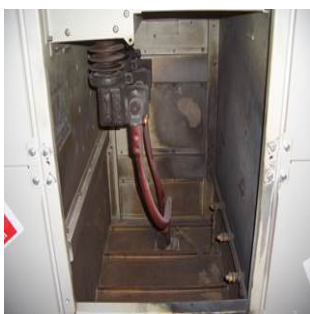
Termination Chamber

During normal site running conditions, an explosion occurred within the termination chamber of a transformer at a Substation, which is one of a number of substations across site and it forms a critical part of the site 11kV network.

Subsequent examination of the cable involved, indicated that the Raychem heat shrink insulation applied to one of the phases was showing signs of heat damage with some partial melting. The insulation is an orange colour and is used to protect the core when the outer insulation is stripped back during installation.

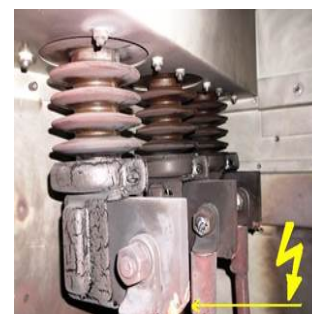
Phase to Phase Discharge

The initial inspection of the components below the vacuum circuit breaker indicated that there had been a phase to phase discharge within the termination chamber (evidence of this is shown in the photo where a discharge occurred between the edge of the busbar nearest the photo and a second phase). It was confirmed that there was no fault to earth.

The initial inspection also concluded that disconnection under fault conditions was virtually instantaneous as there was no evidence of any copper residue “splash” on walls or on the inside of the chamber. This indicates that all circuit protection operated and discriminated as per the

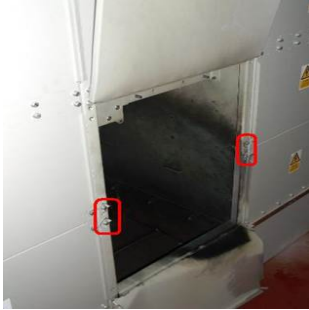
Retaining Nuts & Square Washers

The rear panel of the switchgear is fitted with bolts that are designed to allow the panel to yield in the event of over-pressure in the chamber. The square washers retaining the panel functioned correctly and the upper and lower section of the panel hinged upwards and downwards respectively.

The photo shows the retaining nuts and square washers (identified by the red rectangle) that secure the panel in normal operational conditions had yielded as per their design.
