INCIDENT ALERT

LOCATION:	ON-HIGHWAY	ALERT STATUS:	Normal
ACTIVITY:	TRANSPORT / DELIVERY	DATE ISSUED:	23/02/2015 12:15:58
SUB ACTIVITY:	ON-HIGHWAY	INCIDENT No:	00402

Truck Wheel Loss

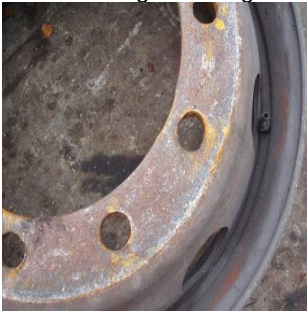
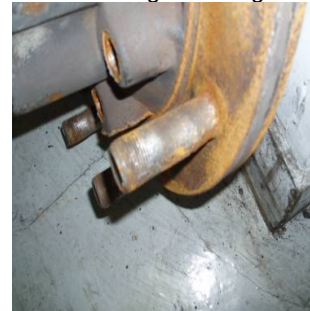
Recently, an articulated lorry lost a wheel on the M45 motorway. The driver felt the steering go slightly sloppy, so started to slow down; however the rev counter shot up even though he was decelerating. After travelling less than 1 mile from the initial suspected fault, the driver pulled over on to the hard shoulder, stopped the vehicle and climbed out of the cab once he had established that it was safe to do so. At this point it was evident that the wheel on the near side drive axle was missing and the second wheel was sitting at an angle. The wheel nuts on the wheel hub had come away completely leaving the studs in place. The wheel was never found.

Following an independent analysis of the remaining wheel studs, the report is inconclusive. The likely cause is both stud stretching, caused by historical over tightening when wheels are changed or worked on, combined with corrosion between the two faces of the drive axle wheels.
