A contractor carrying out a quarry earthmoving campaign was required to cease operations and was expelled from the site on grounds of unsafe practices.

END TIPPING

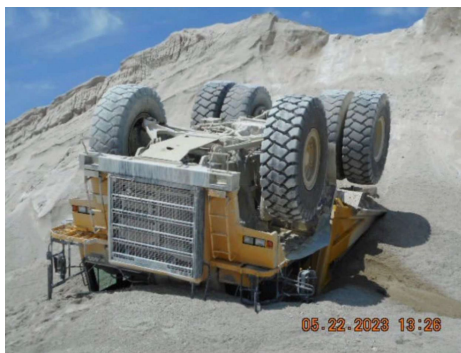
Please see below an example of **end tipping** that occurred in the USA. This incident resulted in a fatality.
