TRANSPORT - HiPo - Truckmixer drum found to be in dangerous state due to poor maintenance regime, it could easily have become detached while vehicle was on-highway

ALERT STATUS: Normal
DATE ISSUED: 28/04/2025 17:26:36
INCIDENT No: 04868

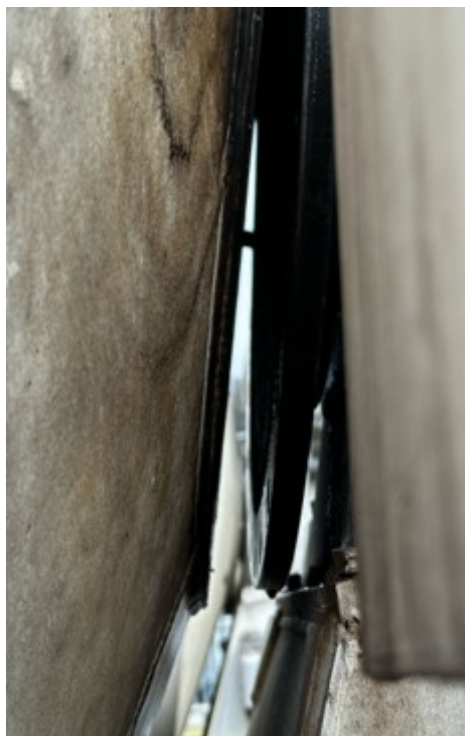
A truck mixer was being loaded with 4m³ of concrete, the first load of the day. Upon noticing a metal-on-metal noise, the driver moved away from the loading bay to investigate the issue. He discovered several of the bolts securing the gearbox and drum had sheared, leaving only three bolts holding the drum in place, see the image below. A new gearbox had been fitted less than 18 months previously.

On inspecting the remaining bolts in the flange, one was identified as a high-tensile grade 10.9 bolt which is the correct bolt for mounting the gearbox & flange to the drum, while the other was a grade 8.8 bolt, more usually found on mounting brackets that allow for movement. **This high potential (HiPo) incident could have had catastrophic consequences if the drum had become detached.**

- The truck owner's incorrect maintenance decisions highlight the need for better understanding of potential consequences of poor decisions and inspection regimes.
- Truckmixer drivers should visually inspect the mixer gearbox mounting bolts (see the image below) as part of their daily pre-use inspection, checking for signs of movement or missing bolts.

- Operators must ensure they follow manufacturers' maintenance guidance in accordance with the specific equipment operators guide (drivers handbook).
- Best practice is to have this area checked during formal documented safety inspections by the vehicle maintenance provider in accordance with a recommended truck mixer inspection sheet.
- Ensure robust defect reporting and rectification schemes are in place, which should be audited and checked by the vehicle owner. This should include procedures which require the vehicle to stop operating if critical faults are found.
