Fatal 5 - Skip full of concrete falls during craning operation

LOCATION: CONCRETE PRODUCTS PLANT
ACTIVITY: LIFTING
SUB ACTIVITY: NO SUB ACTIVITY AVAILABLE

ALERT STATUS: Normal
DATE ISSUED: 18/09/2025 11:34:58
INCIDENT No: 04928

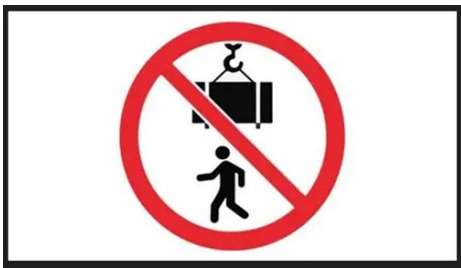
A recent incident at a concrete products site resulted in a skip full of concrete falling from height whilst it was being craned into position. Investigation revealed that this was due to the failure of a master link. The master link was within the 6 month statutory inspection period and no visual damage was seen prior to the link failing.

No person was injured as a result of the incident, but it does reinforce the need to ensure we have no persons operating close to or under any suspended loads.

- Ensure a distance can be kept from all suspended loads, including when they are being moved.
- Never allow anyone to work close to or under a suspended load.
- Consider the use of remote pendants to allow the crane operator to stand clear.
- If the load requires a tag line, make sure the tag line is long enough to allow the operator to safely guide the load.
- Ensure all items for lifting are covered within the Statutory Inspection, including lifting devices that are permanently attached to machinery.
- Consider the age and use of the lifting equipment and make arrangements to replace as deemed necessary – manufacturers guidance and recommendations must be reviewed.

There are no mandatory or industry advisory guidance for replacement intervals of metallic lifting accessories, but we must adhere to guidance for non-metallic items such as straps and slings.
