FIRE - Fire in transfer chute caused by hot lime trapped in rubber liner

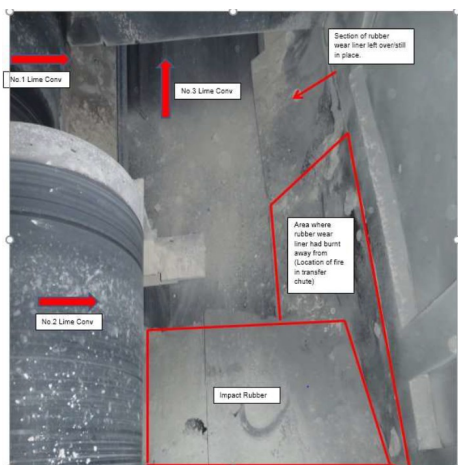
A small fire occurred in a transfer chute between lime discharge conveyors in the shaft kilns basement. The fire was detected by an employee who raised the alarm. The site team responded and used fire extinguishers and a fire hose to extinguish the fire. The damage was limited to the rubber wear liner in the chute but no further impact to the plant.

- Rubber liners made from heat resistant conveyor belt rubber were in place in the transfer chute.
- Over time the resistant rubber had worn exposing the core fibres of the liner and creating a hole in which lime could build up.

- Hot lime (~200c) became lodged in the hole in the liner and began to smoulder before breaking into flames and burning the rubber liner.
- The site team followed the emergency response plan and dealt with the fire quickly preventing further impact.

- The liner was on a 12-month replacement schedule but had worn more quickly due to additional kilns being online producing more product therefore increasing wear.

- Ensure no combustible materials are present in transfer chutes and discharge areas from kilns where hot lime is present.
- Consider more advanced fire detection and suppression systems for high-risk fire locations such as kiln discharge areas.
- Review maintenance schedules to take into account increases and decreases in production and how they affect wear and maintenance schedules on plant equipment.
- Ensure regular emergency response drills are carried out to ensure site teams effectively respond to fire incidents.
- Ensure adequate fire fighting equipment is available in high-risk fire locations and staff are trained to use it.
