Contractor trapped his thumb during lifting operation and sustained fracture

LOCATION: CEMENT PLANT ALERT STATUS: Normal

SUB ACTIVITY: NO SUB ACTIVITY AVAILABLE INCIDENT No: 04943

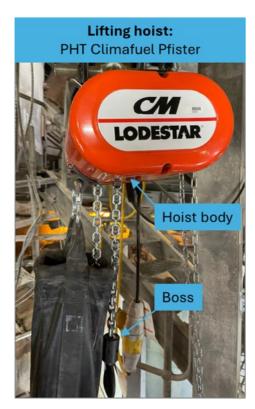
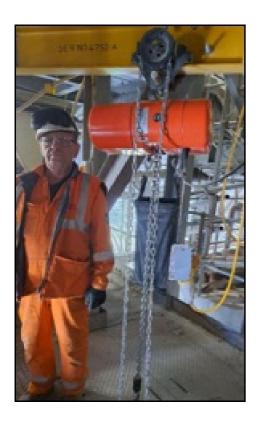
The image on the left shows the boss whilst in a lowered position. The second image shows the boss in its upper trip position between the shoulders of the casing and illustrates how, despite the 'safety gap', it is still possible for the thumb to be nipped (the blue spot shows where the gloved thumb was caught). The final image shows the relative height of the beam and the limited space available.

The injury occurred when the injured person (IP) attempted to manually guide the load by holding the hook during hoisting. A moments loss of concentration resulted in the IP's left thumb becoming trapped.

A contributing factor to the incident was the design of the lifting beam and hoist setup. Due to space constraints caused by surrounding equipment, the chain lift point cannot be centrally aligned with the trap door, requiring the IP to manually guide the load into position. Additionally, the hoist was mounted at head height (again due to space constraints), creating an accessible nip point between the hook and the casing.
