# Slips, trips and falls - Employee sustains ankle injury whilst water jetting at in the pre-heater tower at a cement plant

**LOCATION:** CEMENT PLANT  
**ACTIVITY:** MAINTENANCE & HOUSEKEEPING  
**SUB ACTIVITY:** WALKWAYS

**ALERT STATUS:** Normal  
**DATE ISSUED:** 25/11/2025 18:46:49  
**INCIDENT No:** 04949

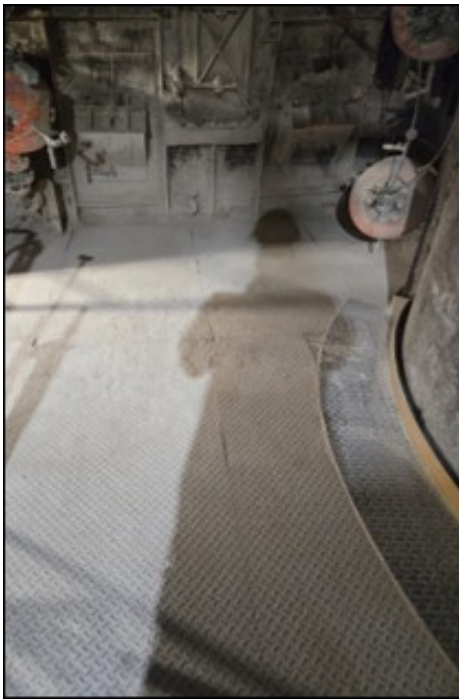
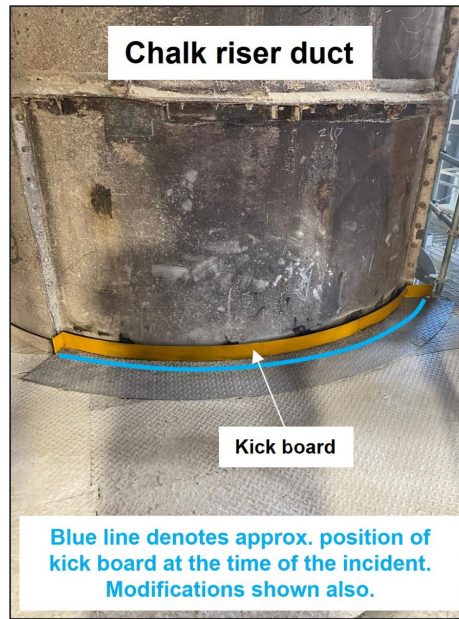
During routine water jetting in the pre-heater tower (PHT), an employee mis-stepped while moving backwards during water jetting, causing his right foot to step into the gap beyond the walkway kickboard. This led him to momentarily lose balance and roll his left ankle. The gap, located between the walkway and the chalk riser duct, measured 18cm and was obviously never large enough for a person to fall through.

The duct's structural flange acts as a natural handrail, guiding individuals away from the gap when adjacent to it. On typical walkways, protected by a handrail, stepping beyond the kickboard often exposes workers to much larger gaps and fall potential. The kick board met the required height and complied with both British and Cemex Standards.

- Water jetting is an activity that does require the operator to step backwards. Where feasible, ensure the area behind is of sufficient space and free of any structures.
- The restricted space on the working platform, a result of the PHT's design (including the routing of ducts), is a contributing factor. To improve the area, the kick board has been moved slightly closer to the duct – see below. Note: the gap cannot be closed completely, and therefore the kick board must remain in order to allow for thermal expansion – the duct runs hot due to process conditions.
