Articulated dump truck rollover

ALERT STATUS: Normal
DATE ISSUED: 11/12/2025 18:58:44
INCIDENT No: 04958

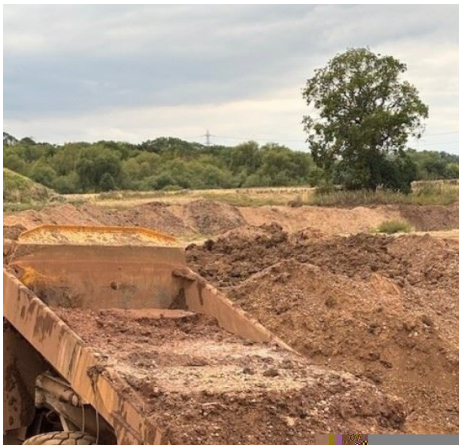
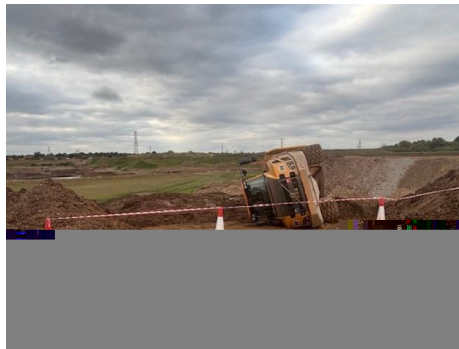
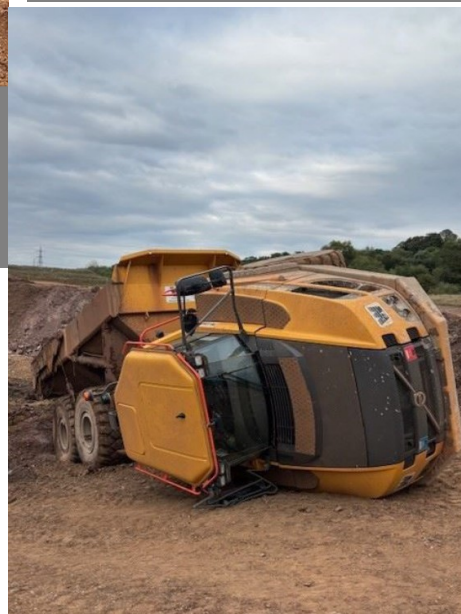
An articulated dump truck (ADT) operator was tipping wet material at a designated tip area, the tip had become full and this resulted in them reversing down and attempting to tip on a steep access ramp. The ADT's inclinometer flagged the position as unstable. The operator moved forward to reposition, which caused the wet material to shift in the skip. After applying the tipping brake and selecting neutral, the operator was preparing to tip when the cab unexpectedly lifted and rolled over.

Violation of given instructions - Driver of ADT did not follow site tipping RAMS, task RAMS stated tipping on level ground.

Inadequate or lack of supervision - Lack of task supervision from site staff and contractor.

Inadequate safe work procedures - Moving/Dynamic load shifting due to wet material slumping towards rear of skip.

No or inadequate correction of identified hazards - The inclinometer takes into account crossfalls not longitudinal angles.

- Site tipping updated to include dynamic loads.
- Spotter to be utilised during evolving ground conditions.
- Tool Box Talk to be supplied to all on-site.
