Fatal 1 - Contractor fails to use correct isolation procedures whilst undertaking maintenance on bucket elevator.

LOCATION: CEMENT PLANT
ACTIVITY: MAINTENANCE & HOUSEKEEPING
SUB ACTIVITY: CEMENT, LIME AND SLAG

ALERT STATUS: Normal
DATE ISSUED: 15/12/2025 18:20:43
INCIDENT No: 04961

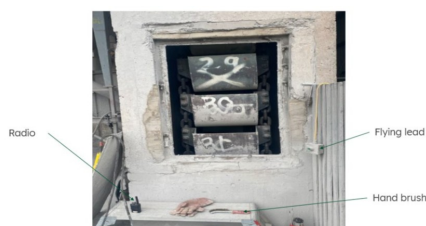
A contractor carrying out inspection work at the bottom of a bucket elevator was not in control of the isolation and had not applied their personal padlock to the local isolator. Confirmation of isolation was being undertaken using a two-way radio to the person located at the top of the elevator. This failure to apply the company's isolation procedures exposed the contractor to the possibility of sustaining a very serious injury or worse.

- Breach of isolation procedures
- Inadequate perception of risk.

- Activity stopped until isolation procedure implemented including personal lock off. Additional controls also implemented to bottom of elevators to allow moving of buckets.
- Internal investigation regarding code of conduct.
- All plants were asked to review the positioning of isolation points, ensuring local isolation points are accessible.
