Fatal 2 - MOBILE PLANT - A cement truck driver, who was outside his vehicle, narrowly avoids being struck by a front end loader.

LOCATION: READYMIX OR MORTAR PLANT
ACTIVITY: PEDESTRIAN AND TRANSPORT SAFETY ON-SITE
SUB ACTIVITY: NO SUB ACTIVITY AVAILABLE

ALERT STATUS: Normal
DATE ISSUED: 28/04/2026 22:24:47
INCIDENT No: 04972

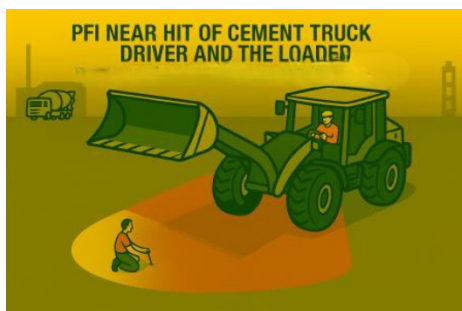
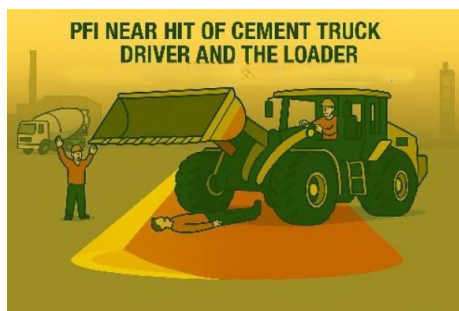
The tanker driver had exited his cab and had entered the movement zone of work machinery/loaders. Although he noticed the loader from a greater distance, he bent down to remove or strike a piece of metal protruding from the concrete surface. At that moment, he was not wearing the required personal protective equipment; specifically, he did not have a safety helmet or high-visibility clothing.

Due to the limited visibility from the loader cabin caused by the raised bucket—necessary because of the fence while crossing the scale—and the position of the tanker driver in relation to the machine's movement, the loader operator could not see him and continued driving directly toward him.

Upon noticing the imminent danger, the tanker driver threw himself to the ground (onto his back) in front of the loader. The loader passed over him in such a way that the wheels went on both sides of his body, without any physical contact. He sustained no bodily injuries, nor was there any direct impact.

The graphics below illustrate the incident.

- Inadequate traffic and pedestrian management in the loader operational zone.
- Insufficient PPE compliance for external drivers.
- Lack of clear communication protocols between drivers and heavy machine operators.
- Unsafe behaviour / risk-taking by the tanker driver (entering danger zone to remove hazard).
- Visibility limitations of the loader (design + operational constraints).

- Redesign traffic flow to separate pedestrians from loader routes.
- Install physical barriers, markings, and controlled walkways.
- Improve visibility: cameras (Camera - 360 degree), sensors, or “blue light” hazard projection from loaders.

- Mandatory PPE checks at entry for all contractors and drivers.
- Strict authorization procedure before entering operational zones.
- Implement communication protocol: eye contact + hand signals or radio confirmation before approaching operating machinery.
- Housekeeping / maintenance system for timely removal of floor hazards.

- Safety induction for all external drivers.
- Toolbox talks for loader operators and plant staff.
- Reinforcement of STOP CARD/LMRA.
