# TRANSPORT - Haulier exposes himself to potential serious injury by working underneath un-propped tipper body with engine running

<b>LOCATION:</b>	<b>DEPOT</b>	<b>ALERT STATUS:</b>	<b>Normal</b>
<b>ACTIVITY:</b>	<b>GUARDING AND ISOLATION</b>	<b>DATE ISSUED:</b>	<b>05/05/2026 13:36:39</b>
<b>SUB ACTIVITY:</b>	<b>NO SUB ACTIVITY AVAILABLE</b>	<b>INCIDENT No:</b>	<b>04974</b>

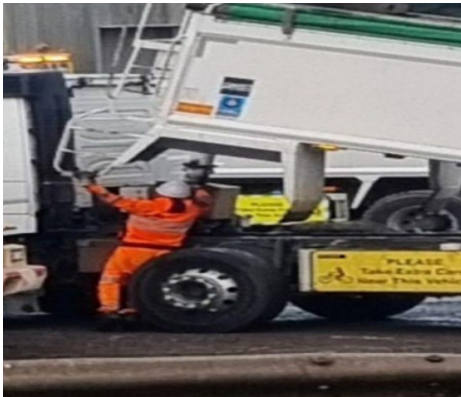
A franchise haulier's driver was seen underneath a raised tipper body with no body props, engine running, and was trying to clean out plainings from the hydraulic tank and vehicle gearbox while having the tipper body raised and unpropped.

**Primary** – The plainings/asphalt crew had left breakout in the road which caused the truck to get stuck momentarily causing the plaining machine to fire plainings over the front of the body and in between the body and cab.

**Contributing** - Driver behavior

- Drivers' handbook to be altered to reflect the importance of NOT getting underneath an un-propped tipper body.
- Safety alert circulated to all haulers and drivers via email and MP Connect App.
- Night Distribution Resource Managers to pick up with all plainings crew and asphalt gangs the importance of not leaving breakout and sweepings in front of the trucks.
- Body props are only to be used by trained/competent LGV fitters with RAMS/ Management approval in place.
- Consideration MUST always be taken to identify and control all forms of stored energy in all tasks to be completed (see list of types of stored energy below)
