TRANSPORT - Individuals at high risk of being hit at asphalt plant during loading out

LOCATION: ASPHALT/COATING PLANT
ACTIVITY: PEDESTRIAN AND TRANSPORT SAFETY ON-SITE
SUB ACTIVITY: NO SUB ACTIVITY AVAILABLE

ALERT STATUS: Normal
DATE ISSUED: 14/06/2026 18:17:23
INCIDENT No: 04980

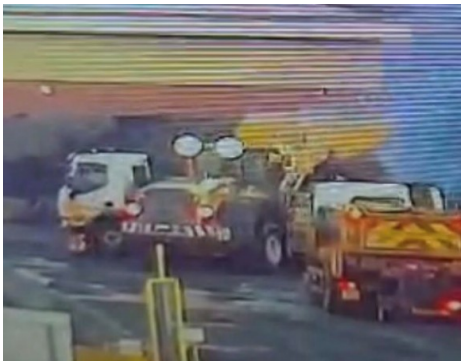
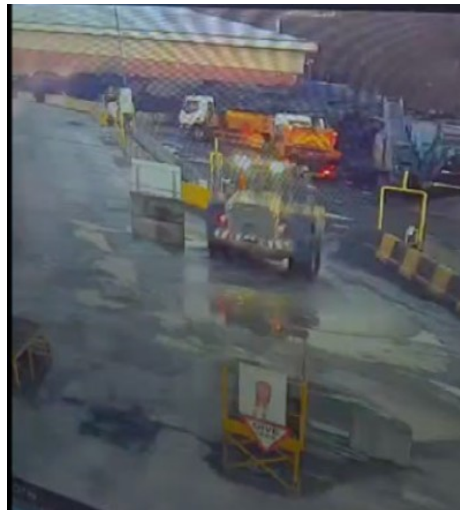
Following the overloading of a hotbox at an asphalt plant, the vehicle was driven to the tip off area, RAP stock yard for the loading shovel to remove the excess material. While the loading shovel was removing the freshly mixed asphalt there were two individuals within the area wearing minimal PPE in close proximity to both the hotbox and moving mobile plant. There was a clear risk of either driver being struck by the front end loader or covered with very high temperature material.

- The operative was not fully focused on the unloading of material onto the hotbox when the discharge gate was opened with the wrong vehicle in position
- A risk assessment was not completed even though this was an activity not covered within daily activity RAMS
- Due to a lack of safety focus on site, resulting from a can-do attitude, procedures were not followed with production put before safety
- PPE signage was not clear within the RAP yard
- A lack of support from the site supervisor to manage the activity safely.

- A toolbox talk on would be given which would cover the importance of undertaking a risk assessment when a new task, not included in daily activity, is necessary and, a reminder of general safe practices on-site.
- CCTV and Tannoy improvements would be made to aid the plant operator when loading material
- A review of PPE signage to be undertaken on site
- Review of training matrices for individuals to be completed.
