INCIDENT ALERT

LOCATION:	ON-HIGHWAY	ALERT STATUS:	Normal
ACTIVITY:	TRANSPORT / DELIVERY	DATE ISSUED:	08/08/2017 10:43:48
SUB ACTIVITY:	ON-HIGHWAY	INCIDENT No:	01463

60t Crane Rollover

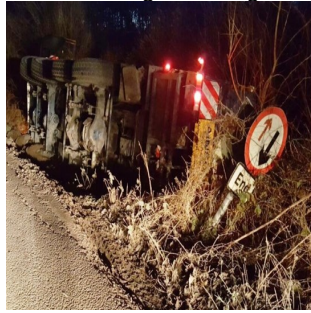
The driver continued onwards and tried to steer the crane out of the rut, but was unsuccessful; the trailing wheels also dropped into the rut and eventually the soft verge gave way, causing the crane to overturn.

Overtuned Crane

- Remind drivers about the dangers of soft verges, and how easily a vehicle can roll over.
- Wearing a seat belt and not carrying any loose equipment in the cab will help to prevent injuries
- Journey Planning should be undertaken for all deliveries, and could identify where an alternative / safer route is necessary. In this case a movement order had been applied for but had not been issued. The Police had instructed the crane provider to use an alternative route but this had not been communicated to the driver.
