## BEST PRACTICE

LOCATION: Railhead      ARTICLE YEAR: 2013  
ACTIVITY: Transport / Delivery      COMPANY: Lafarge Tarmac  
SUB ACTIVITY: Rail      COMPANY LOCATION: Mountsorrel Quarry, Barrow Railhead  
BEST PRACTICE No: BP890      COMPANY TEL: 07803 95 3658  
COUNTRY OF ORIGIN: United Kingdom

Simple visual indicators to prevent slow speed shunting collisions on railhead

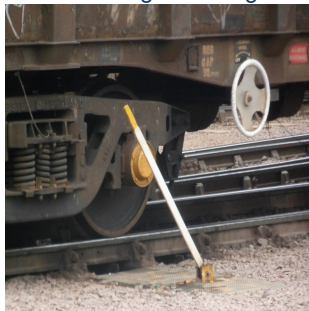
Before

In 2011 and 2012, the 3M tonne per annum railhead at Barrow on Soar experienced 3 instances of very slow speed shunting collisions within the sidings, causing damage to wagons and infrastructure and disrupting the railhead operations. The accidents were either caused by parked wagon sets 'partially fouling' points so that wagon sets on adjacent lines could not pass without touching, or were due to over shunting wagon sets into the stop blocks.

A review noted that there were no visual markers to show whether the parked sets were sufficiently clear of the points to allow safe passage. Operators were using their judgement and experience to 'visually assess' whether there was sufficient clearance. The solution was to mark back from the stop blocks and points the clearance distance by painting the track sleepers in red – creating a clear visual marker – without creating a trip hazard. The method of working was adjusted so the shunting was undertaken at normal speed until the last three wagons and then slow speed until beyond the markers.
