- BITUMEN TANK FIRE 2020

What Happened

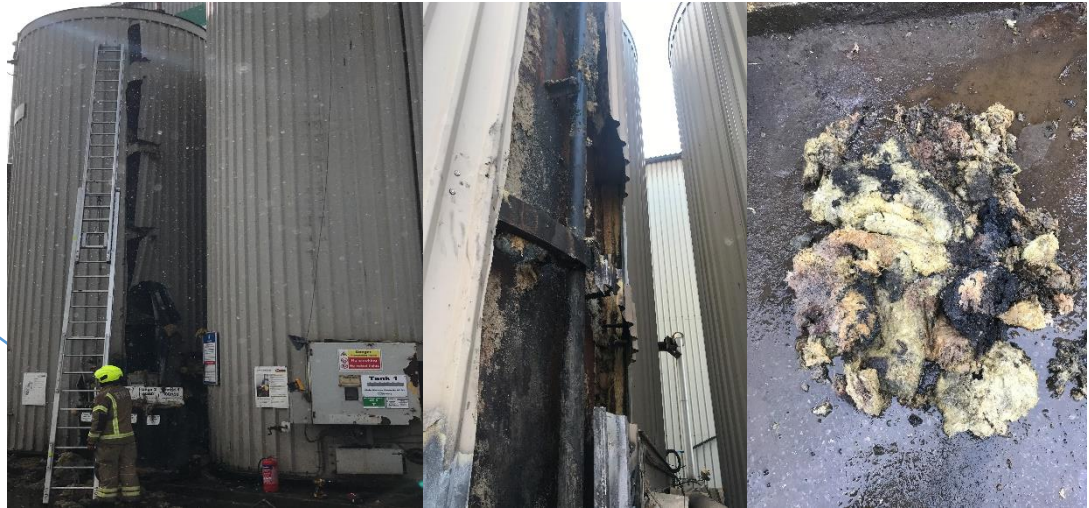
Product identified in cladding and around inlet pipe – no tank fracture and inlet pipe not for that tank

Ignition occurred following morning as a result of heat from the tank allowing lighter oils released from pipework volatilize effect – pipe fracture identified - aged insulation (>20years) disintegrated acting as a wick. By removing the cladding to check issue effectively open to air oxygen introduced and over 8hours unseen smouldering occurred to enable ignition after glowing effect
