## Major Equipment Damage/High Potential Incident Faulty wheel rims

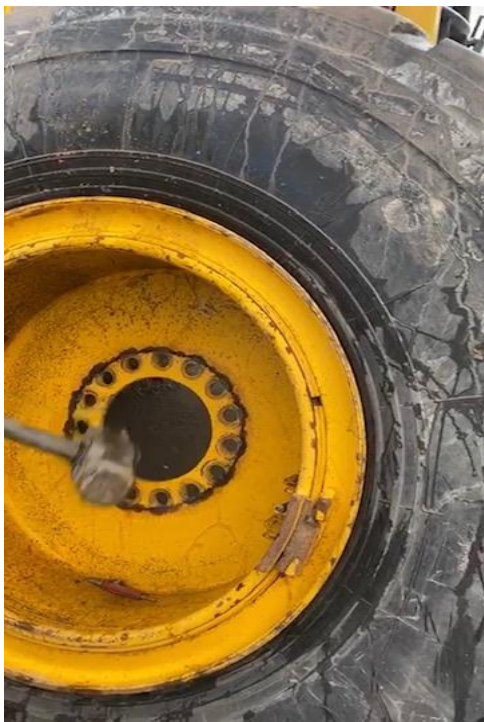
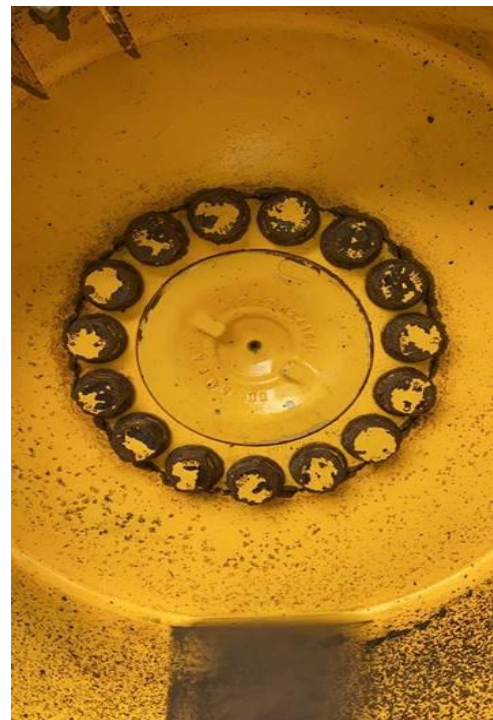
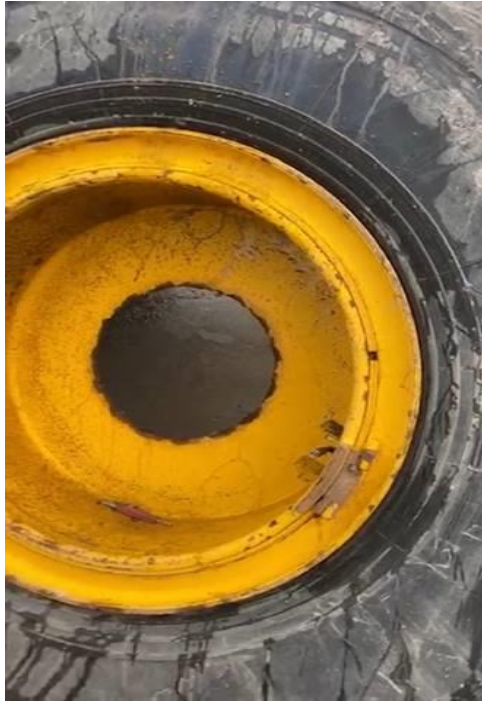
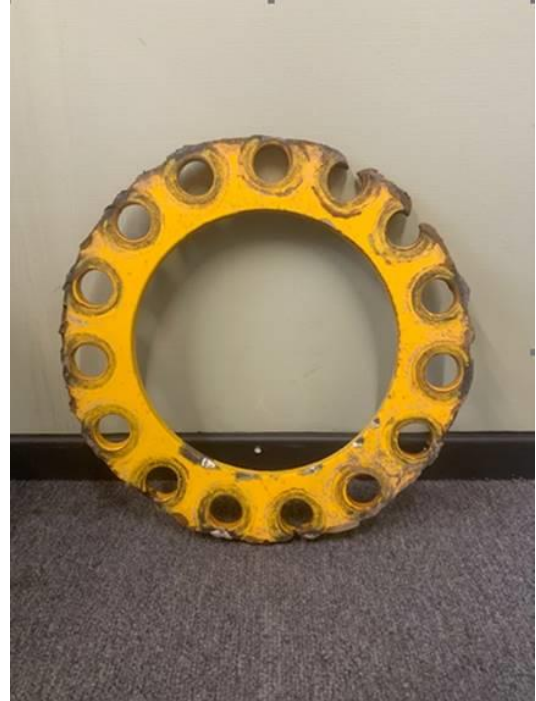
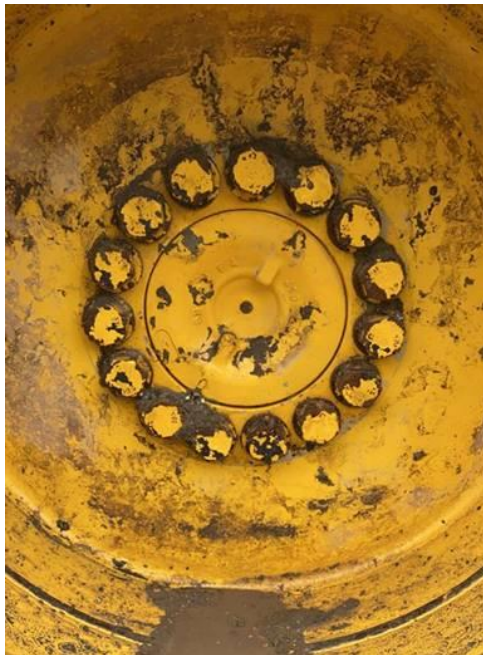
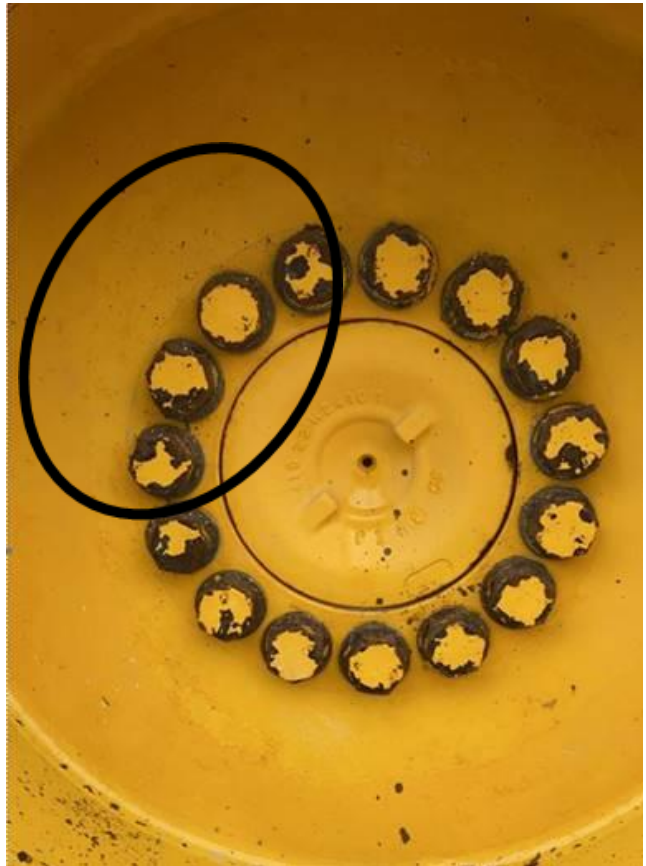
On an inspection carried out by our engineer on a Komatsu WA 320 Loading Shovel at an Asphalt plant. It was noted that there was a crack travelling from the holes of each wheel stud, at first glance it probably looks like only the paint work had cracked, but after cleaning the area with a pressure washer and closer inspection it was confirmed that this was actually a crack in the rim itself. The machine was immediately put into quarantine and further inspection carried out; another hair line crack was found on the opposite wheel and another in one of the front wheels.

This could have potentially caused a major equipment failure with catastrophic consequences.

Four new wheel rims were ordered and fitted by an external Tyre company.

We are in the process of checking all other shovels, but this seems like an isolated incident.

All managers are to emphasise the importance of Vehicle and Plant daily checks and not just to tick the sheet, making sure plant is kept in the cleanest of conditions as dirt can easily mask or mislead the operator.
