Industry Safety Alert

GAS Explosion

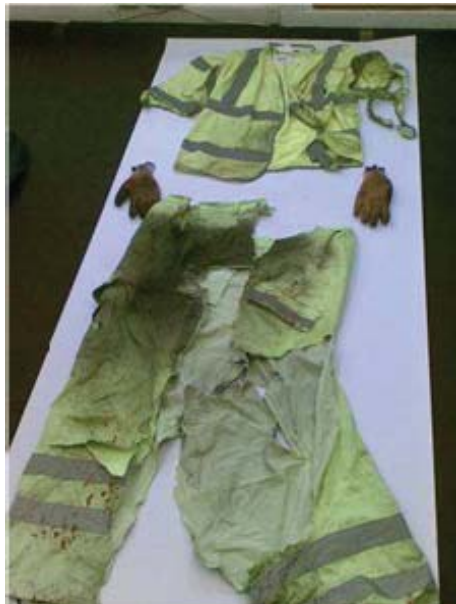
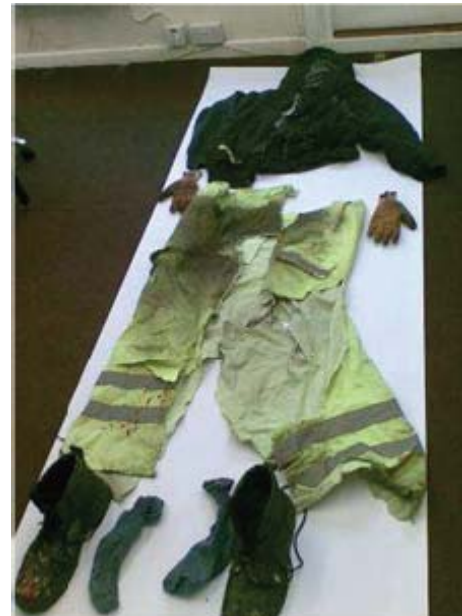
The explosion occurred when the operative pushed a pedestrian thermoplastic pram (manually operated, gas fed pram which has a naked flame) towards a BT chamber, which had become contaminated with natural gas. It is now known that the naked flame on the pram ignited the gas which had built-up within the BT chamber causing a significant explosion, which blew the operative to the ground, partially ripping off items of his PPE, trousers, jacket and gloves.

The blast was large enough to expel both sections of a two part heavy duty ductile iron cover a considerable distance, narrowly missing the employee and a passing vehicle. The injured person was part of a two man road marking team, and sustained serious burns to his torso, arms, wrists, hands and slightly lesser burns to his legs.

The IP's PPE following the Incident

- Take extra care during the initial site risk assessment and consider the potential presence of gas.
- Stop or do not commence any hot works where there is a suspected gas leak (odour or noise)
- All lining works near ironworks **MUST** be applied by hand.
- Flame retardant PPE (including trousers) **MUST** be worn at all times when conducting any works which involve a naked flame.
