Hazemag crusher incident

Hazemag crusher at Clee Hill Quarry in the Central Region.

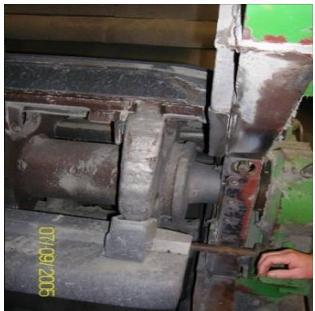
On the 17th June 2005, two employees were tasked to change the blow bars of the Hazemag impact crusher – the tertiary crushing operation at the Clee Hill Quarry site. The blow bars are positioned on four arms of a rotor shaft located at 90° to each other. There are two blow bars per arm, each weighing over 100 kg when new. To safely remove the blow bars, a locking pin is inserted into the rotor flange through the crusher casing, and this secures the rotor from movement. Employees can then remove blow bars safely, normally swapping them "old for new" before turning the shaft. On this occasion all blow bars were being removed so the shaft could be inspected. When the first set of bars were removed it was necessary to move the now out-ofbalance rotor shaft, to its next position. This is normally undertaken manually by the operatives undertaking the task. As the rotor was moved over to its next position the weight of the out-of-balance rotor created an inertia effect, resulting in one of the employees trapping his finger between the rotor arm and the crusher casing. This resulted in the employee's middle finger being badly lacerated, requiring several stitches at the local hospital.

This picture shows nip point where the employees finger became trapped against the casing of the crusher and the rotor arm

5. A hazardous nip point on the machine was not recognised.

3. A risk assessment and safe working practice has been developed.

4. Discussions are being held with Hazemag over the suitability of an indexing device to control the rotor movement.
